Advanced Manufacturing Development of a Composite Empennage Component for L-1011 Aircraft

QUARTERLY TECHNICAL REPORT - NO. 9

This report is for the period 1 January 1978 through 31 March 1978

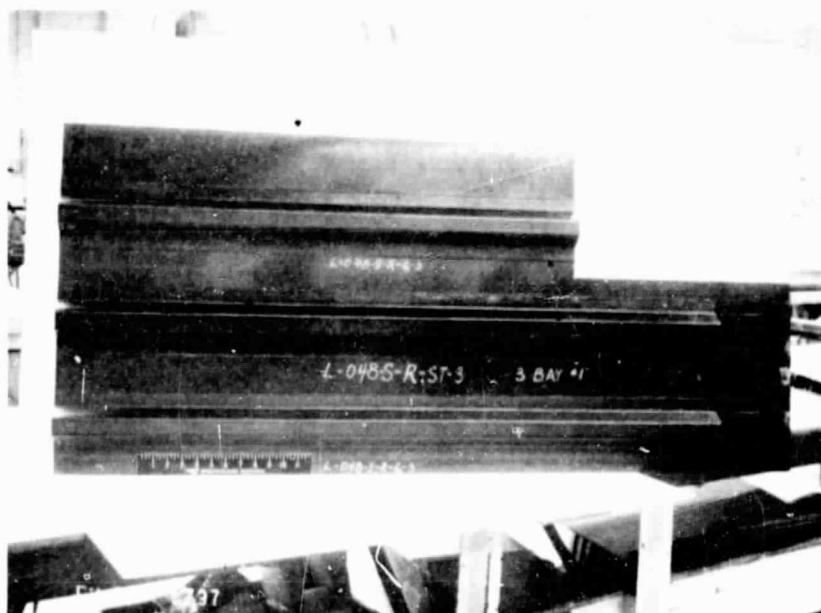
Figure 2-10. Three Hat Wide Cured Panel

An additional panel was fabricated using a convention 250°F cure cycle with 350°F postcure. This panel was 44 inches long and was three hat bays wide. Its purpose was to determine what effect, if any, a series of adjacent hats single-stage cured to a skin would have on the hat/skin assembly, particularly in the skin area between hats, and also to observe any variations due to the use of the solid rubber mandrel in combination with alternate caul materials. In the assembly, a fiberglass/phenolic caul was used on one outer hat, a fiberglass/epoxy caul on the other outer hat, and a steel caul on the center hat. This panel is seen in Figure 2-10. Examination of the panel indicated that no discrepancies were introduced by the multiple hat configuration. Again, the hat definition appeared to conform closely to caul variations. The fiberglass/phenolic caul, in particular, contained areas where the flange-to-skin radius was not sharply defined and the same condition was evident in the laminate in those areas.

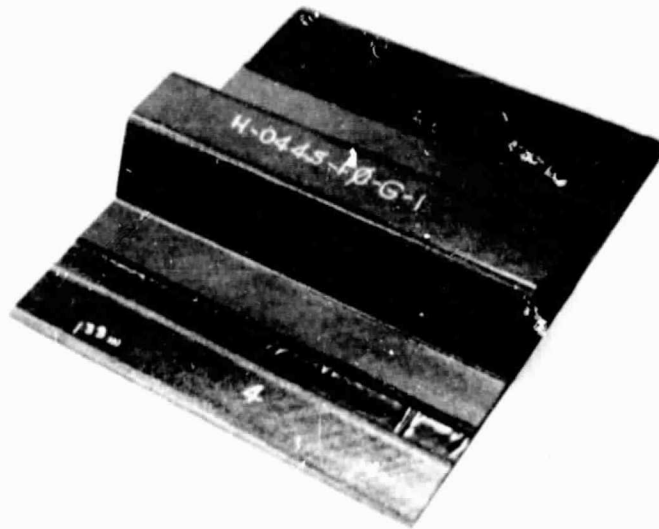
Figure 2-12. Hat-to-Skin Assembly Using a Foam Mandrel

A review of these results indicates that the foam mandrel concept is capable of producing satisfactory parts. NDI results verified external discrepancies noted by visual examination. Figure 2-12 shows a portion of this assembly. The wrinkled portion shown adjacent to near flange is due to the use of a rubber strip adjacent to the flange during cure. This was done in an attempt to assure application of pressure at the edge of the hat flange. This part was cured using a fiberglass caul. The prebled hat and skin layup was cured at 350°F.

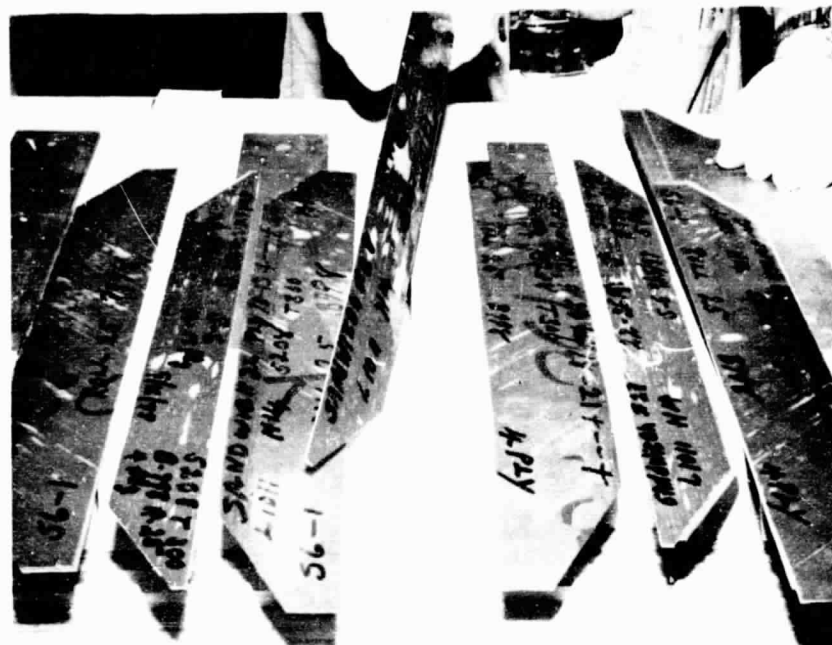
Figure 3-5. Stiffener Trim Templates

The process verification test specimen (Test Item H14) represents the lower 84-inches of the front spar. It was fabricated in an 8-foot, stub spar tool, and subjected to FAA and Company conformity inspection requirements. The layup of the stub spar is shown in Figures 3-5 through 3-10. Figures 3-11 through 3-15 shows the spar after removal from the bond tool prior to removal of the armalon and clean-up.

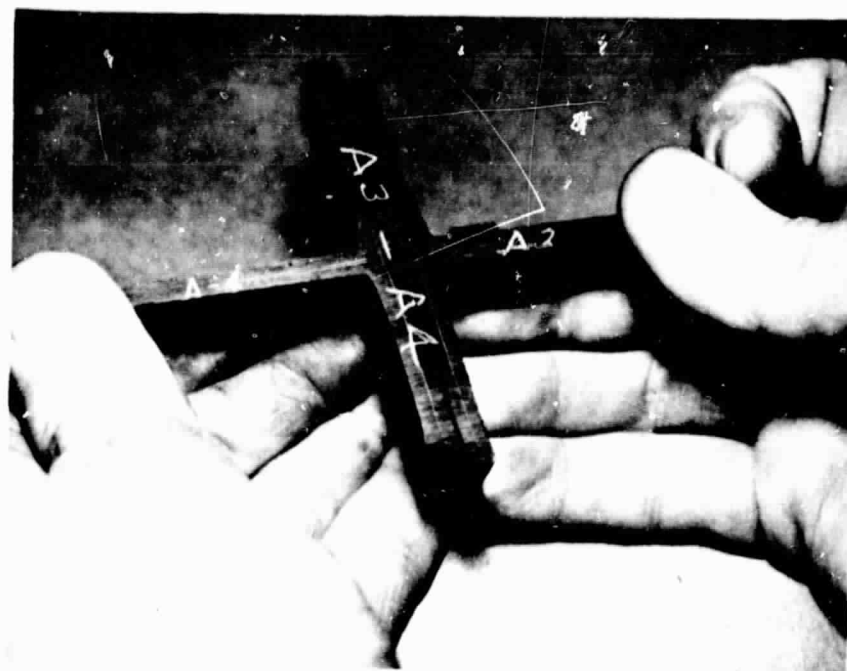
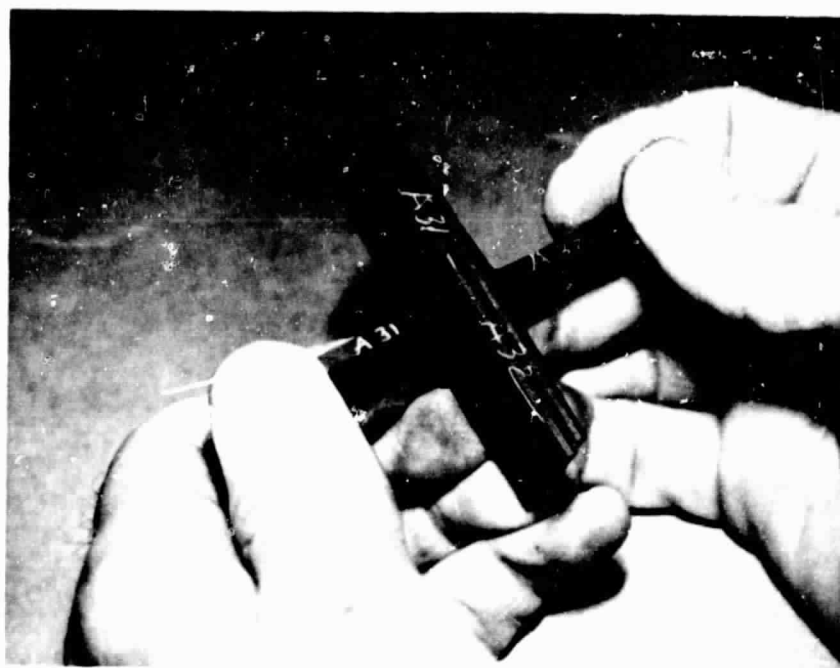
Figure 3-25. Specimen A Interlaminar Tension Failure Mode

Predicted compression loads and compression stresses are shown by the numbers in hexagons below the RH cap in Figure 3-23. These predicted values also apply to the opposite specimens in the LH caps. As shown, the test values were all above those predicted. Figures 3-25, 3-26 and 3-27 show typical failed specimens.

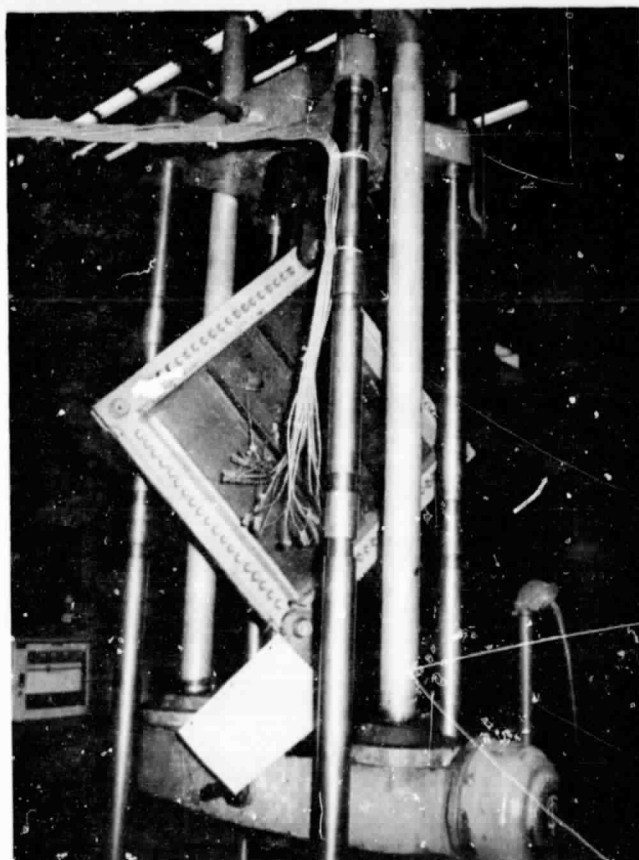
Figure 3-33. Test Set-up for H21A-1 RTD Shear Web Specimen

The H21A-1, RTD shear panel with two stiffeners and 4-inch diameter, unreinforced access hole was static tested to failure. Figure 3-33 shows the test set-up. This panel represents the highest loaded section of the web in either the front or rear spars. The panel held 170 percent limit load, and the gages were read at this load before failure.

The failure mode shown in Figure 3-34 was almost identical to the failure mode for H21B shown in Figure 3-10 of Quarterly Technical Report No. 8. Both H21A-1 and H21B failed after reading the strains @ 170 percent design limit load; the strains were similar and indicated that web buckling occurred prior to failure. H21X, the first of this series of panels, was rejected because of delaminated stiffeners and over thickness tolerance. H21X was repaired, as shown in Figure 3-1 of Quarterly Report No. 8, tested and failed at 188 percent design limit load.
